Killer landslide

Alberta's infamous Frank Slide, Canada's deadliest, is replicated in amazing detail

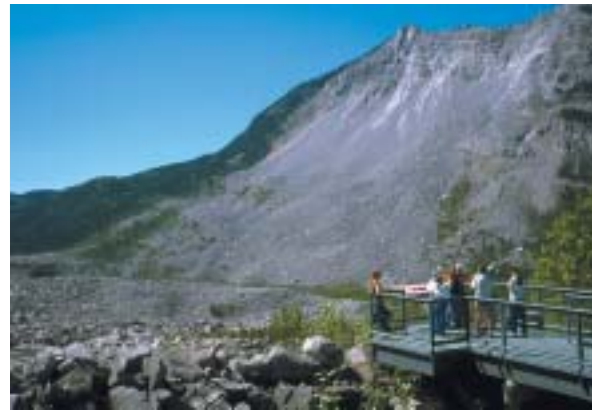
An observation deck overlooks the slide site today. The slope of Turtle Mountain was deemed potentially unstable in the years following the disaster, prompting most residents to relocate to a new townsite away from its ominous shadow.

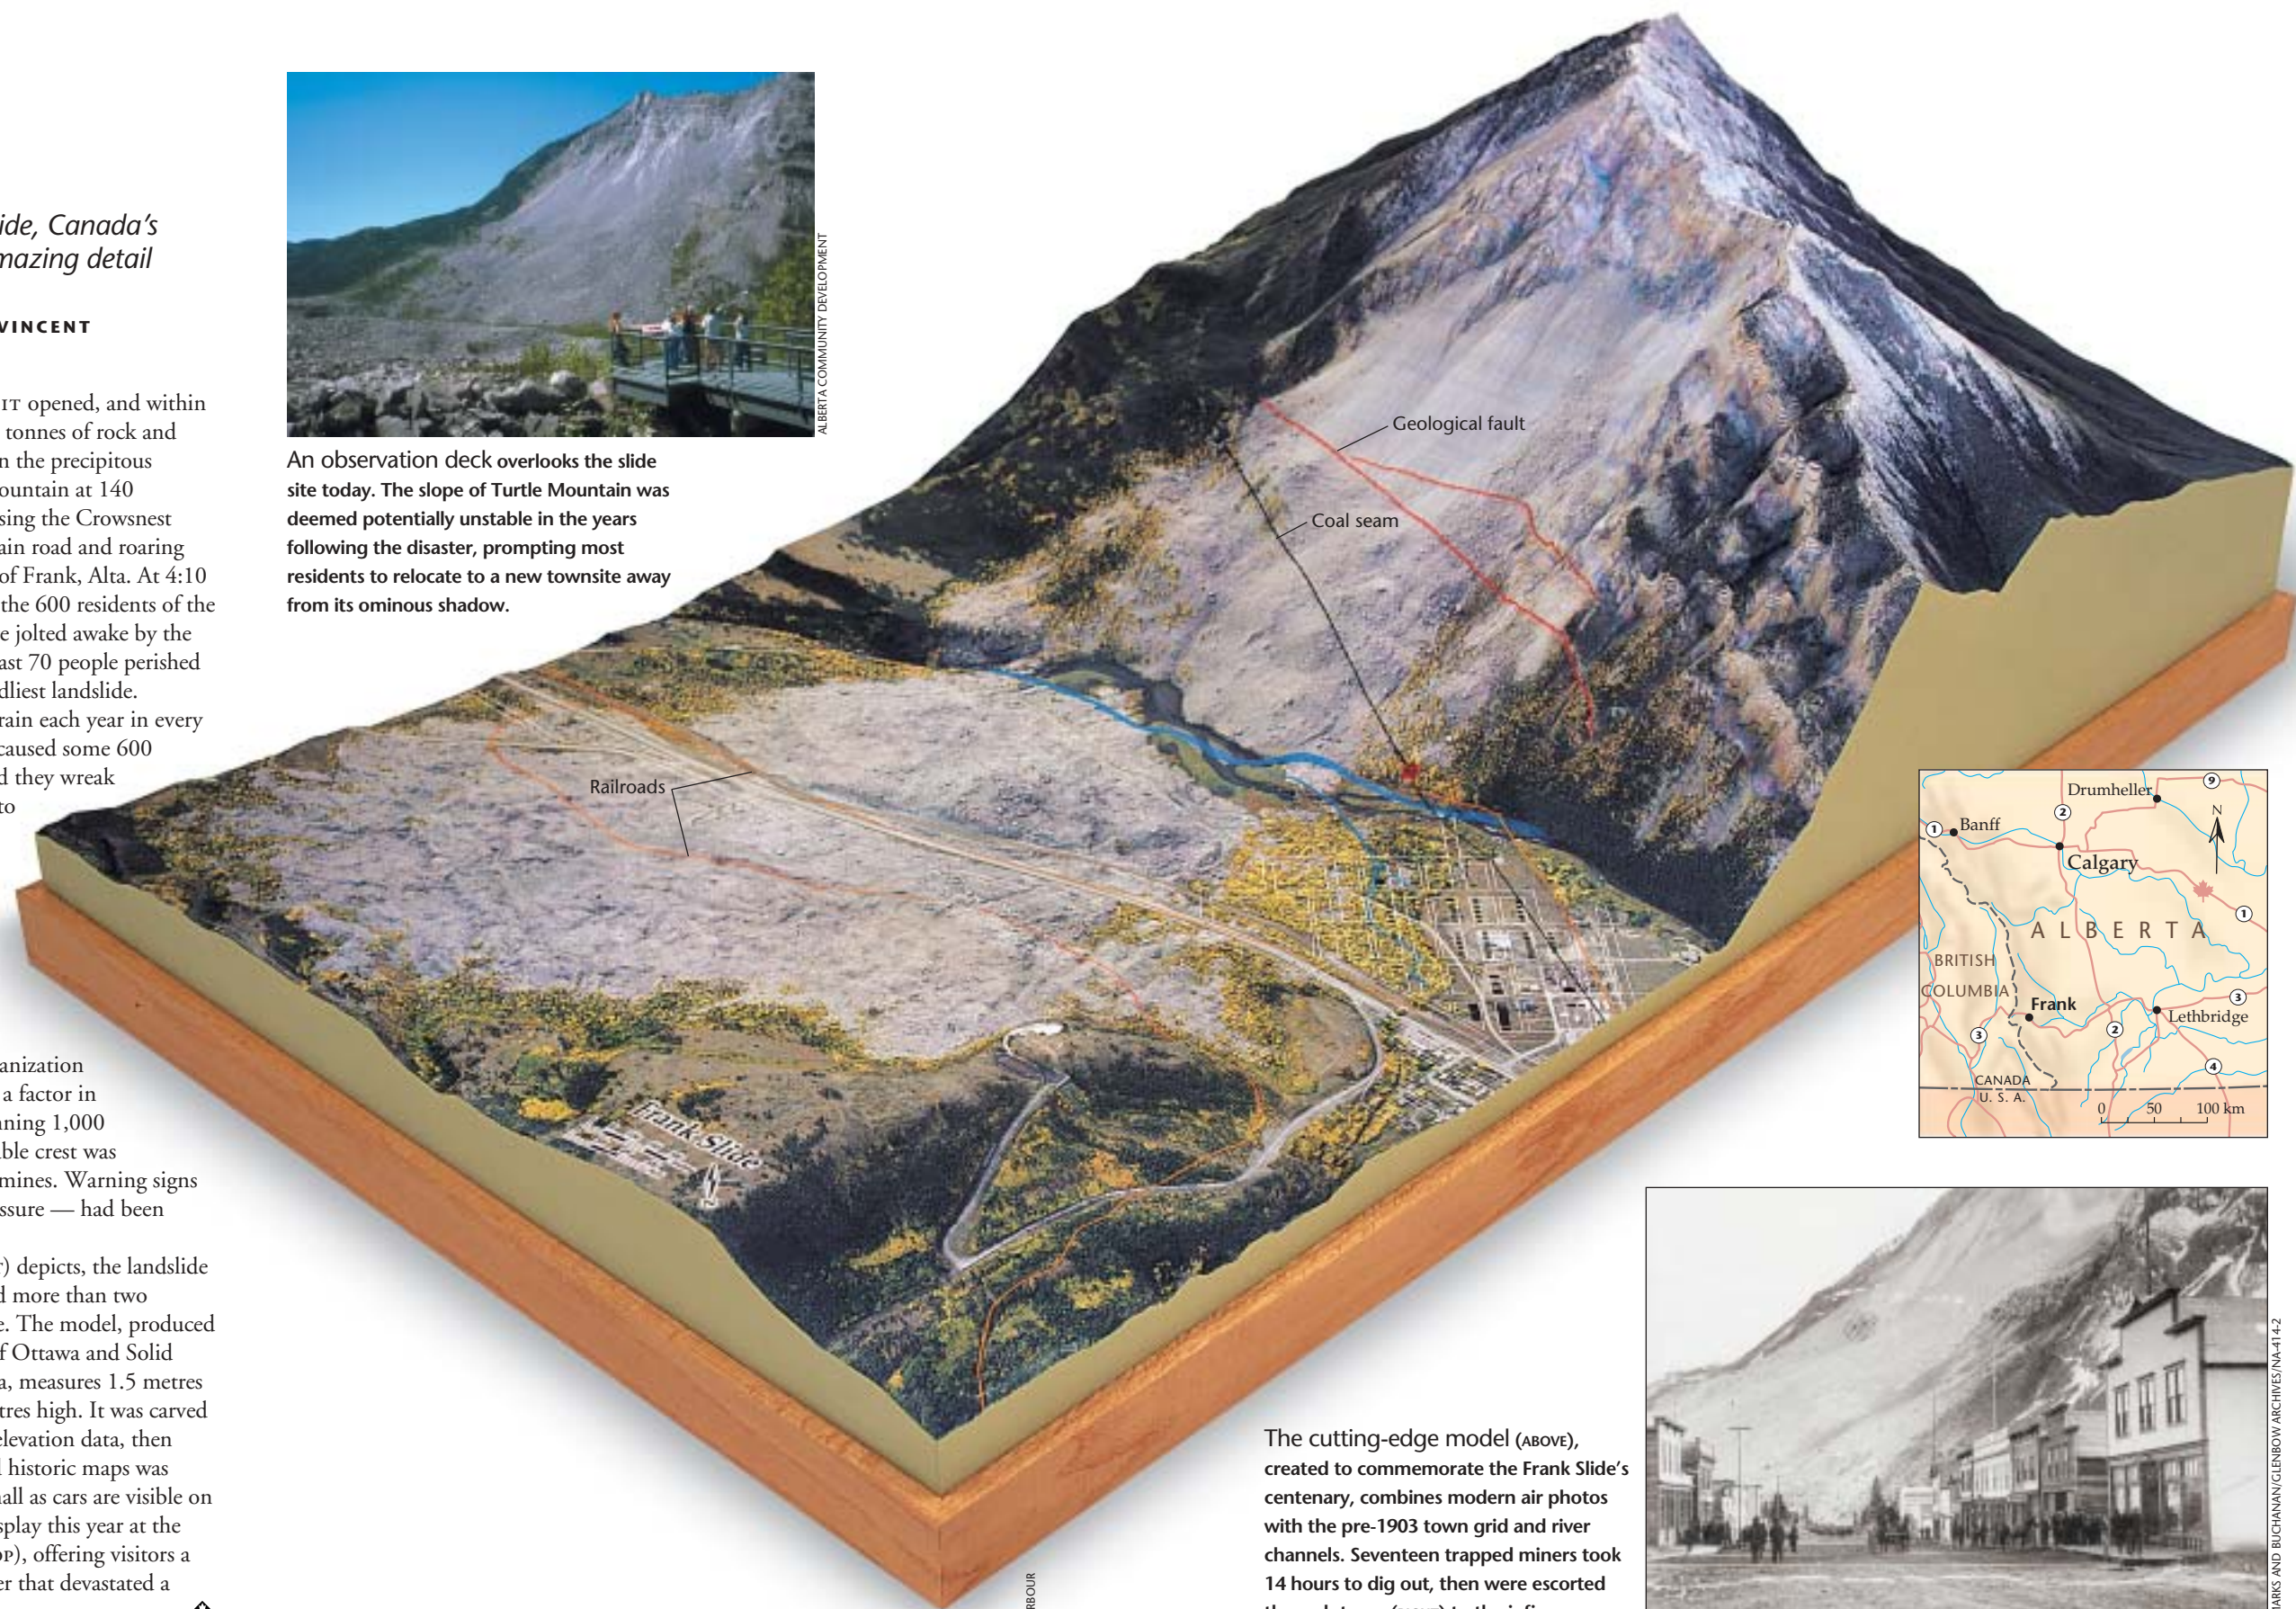
The cutting-edge model (ABOVE), created to commemorate the Frank Slide's centenary, combines modern air photos with the pre-1903 town grid and river channels. Seventeen trapped miners took 14 hours to dig out, then were escorted through town (RIGHT) to the infirmary.

As the 3-D terrain model (RIGHT) depicts, the landslide flowed like thick liquid and reached more than two kilometres from summit to advance. The model, produced by GeoSolutions Consulting Inc. of Ottawa and Solid Terrain Modeling Inc. of California, measures 1.5 metres long, 1 metre wide and 40 centimetres high. It was carved in high-density foam using digital elevation data, then information from aerial photos and historic maps was printed on its surface. Details as small as cars are visible on the model, which will be put on display this year at the Frank Slide Interpretive Centre (TOP), offering visitors a new perspective on a natural disaster that devastated a young community a century ago. ♦
